AN IN-SEAM SEISMIC (ISS) METHOD BASED MINE VOID DETECTION TECHNIQUE

FINAL REPORT FOR PHASE I

U. S. Department of Labor
Mine Safety and Health Administration
1100 Wilson Boulevard
Suite 2132
Arlington, Virginia 22209 – 3939

October 29, 2006

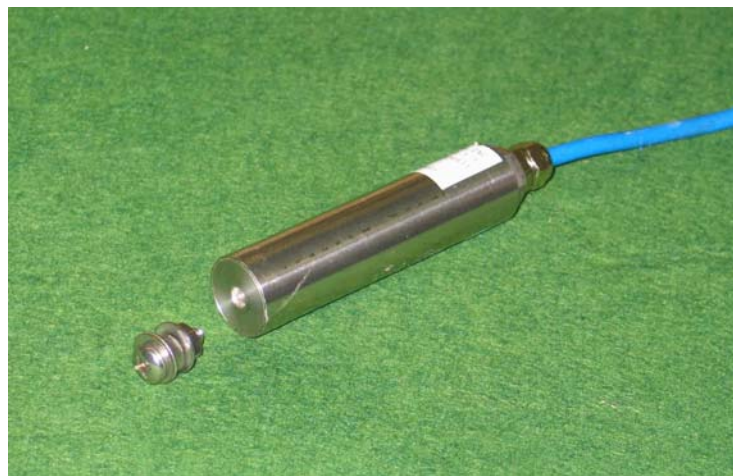
Figure 2.1 A retrievable uniaxial sensor consists of a sensor body and a sensor anchor made of a screw assembly.

A retrievable uniaxial sensor consists of two parts, a sensor body and a screw assembly (Figure 2.1). The screw assembly is the anchor of the sensor, grouted at the bottom of the sensor hole. Figure 2.2 is a schematic illustration of a retrievable sensor installed at the bottom a borehole.

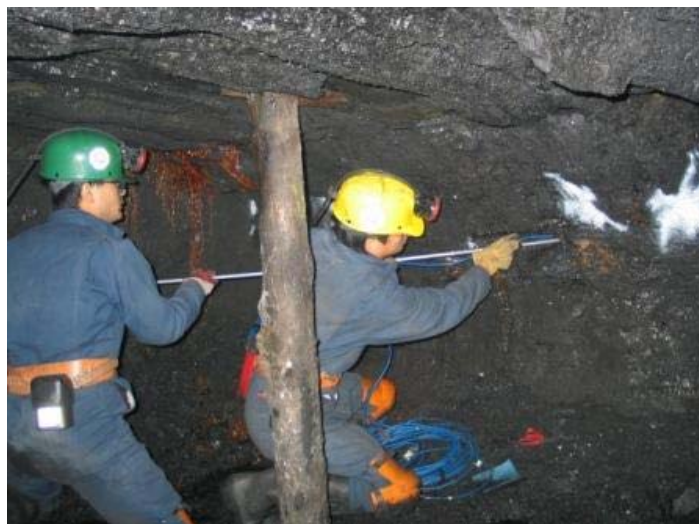
Figure 2.3 Installation of a retrievable sensor at the Harmony Mine.

The retrievable sensor installation technique was used for all seven field tests carried out by Penn State. It is simple and convenient for both installation and retrieval operations. Figure 2.3 shows sensor installation by the Penn State crew at the Harmony Mine. Most importantly, the technique is reliable for acquiring broadband signals, including high frequency signals. The signals shown in Figure 2.4 are the reflected S-wave signals recorded at General Chemical trona mine. The dominant frequency for these signals is 2500 Hz. The amazing fact about these high frequency signals is that they had traveled 700 ft. Without a superb coupling effect, this would be impossible. All our field tests have demonstrated that the performance of the technique is predictable, consistent, and repeatable.

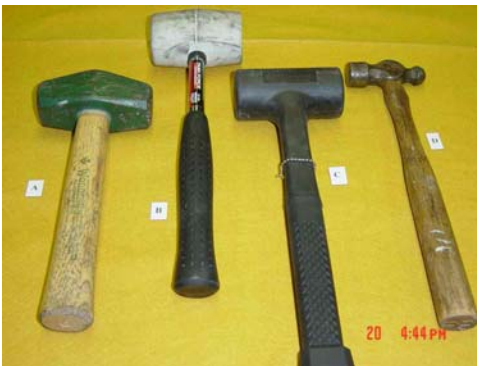
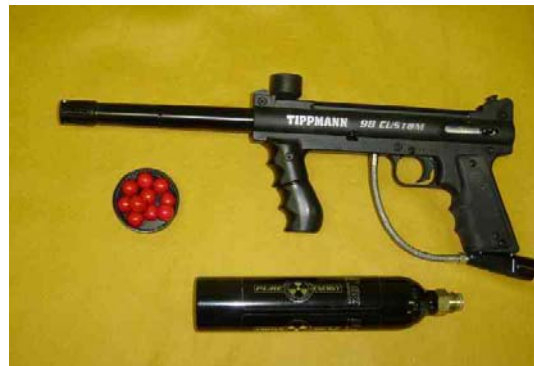
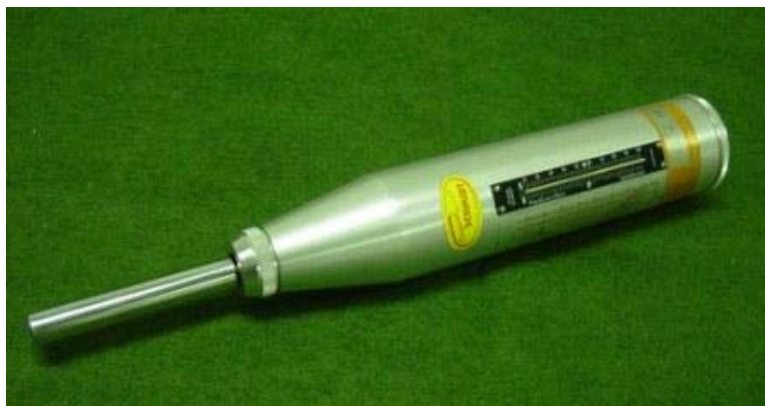
Figure 2.16 Types of the mechanical sources tested.

a. Four different hammers.

b. Pneumatic source (“paint gun”).

c. Schmidt hammer.

The mechanical sources which were tested include:

- metal hammers (0.75 lbs) (Figure 2.16a),
- metal hammers (3.25 lbs) (Figure 2.16a),
- rubber-headed hammer(1.28 lbs) (Figure 2.16a),
- special non-rebound hammer (1.72 lbs) (Figure 2.16a),
- pneumatic source (Figure 2.16b), and
- Schmidt Hammer (Figure 2.16c).

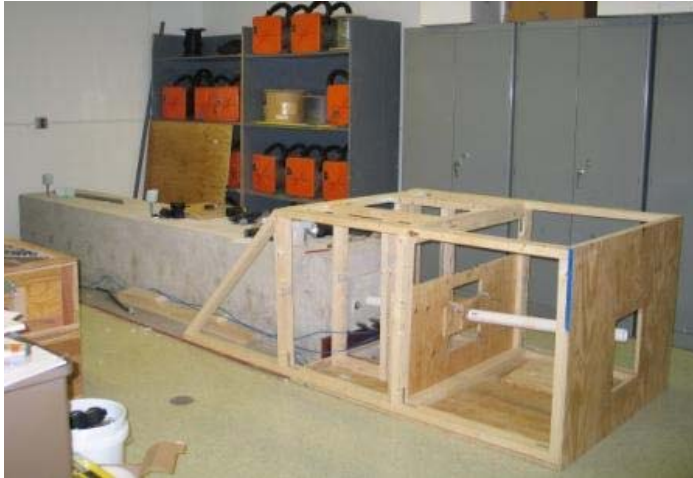
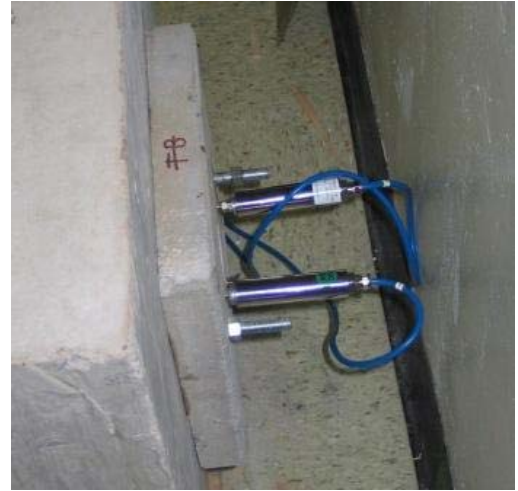
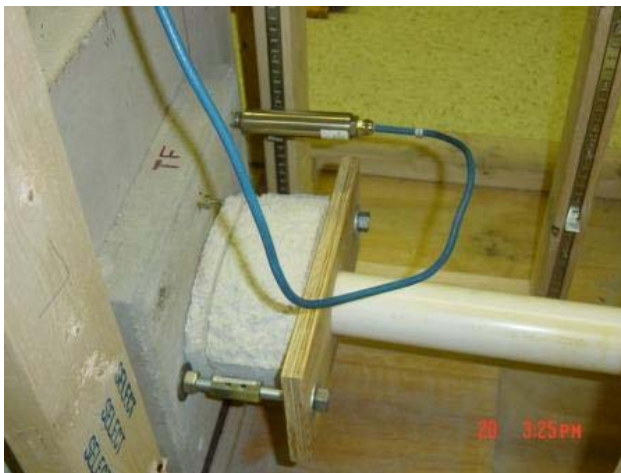
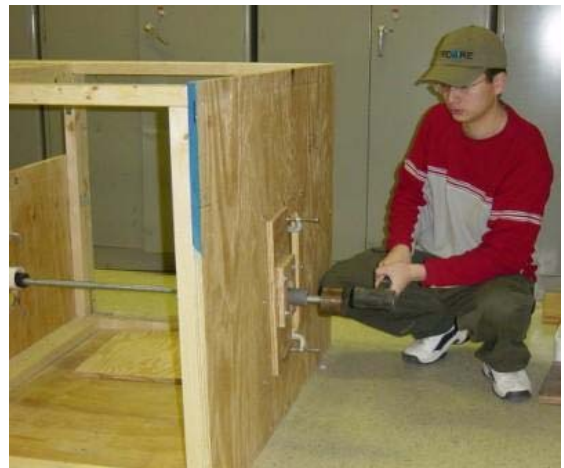
Figure 2.17 Testing facility and arrangement for non-explosive seismic sources.

a. 2 ft x 2 ft x 12 ft concrete block and attached testing frame.

b. Sensors and sensor panel attached at the rear end of the block.

c. Sensor and testing panel installed at the front of the concrete block.

d. Using SMIS for a hammer impact test.

The basic testing facility for non-explosive seismic sources includes a 2 x 2 x 12 ft³ concrete block and an attached testing frame specially designed and constructed for this project (Figure 2.17a). Sensors may be installed at three general locations, depending on the testing need. One is at the top of the block where sensors can be installed in several existing sensor holes which were prepared during the construction of the block. The other two locations are the rear end and front end of the block (Figure 2.17 b & c). Special concrete panels were designed and attached to the block at these locations for sensor installation.

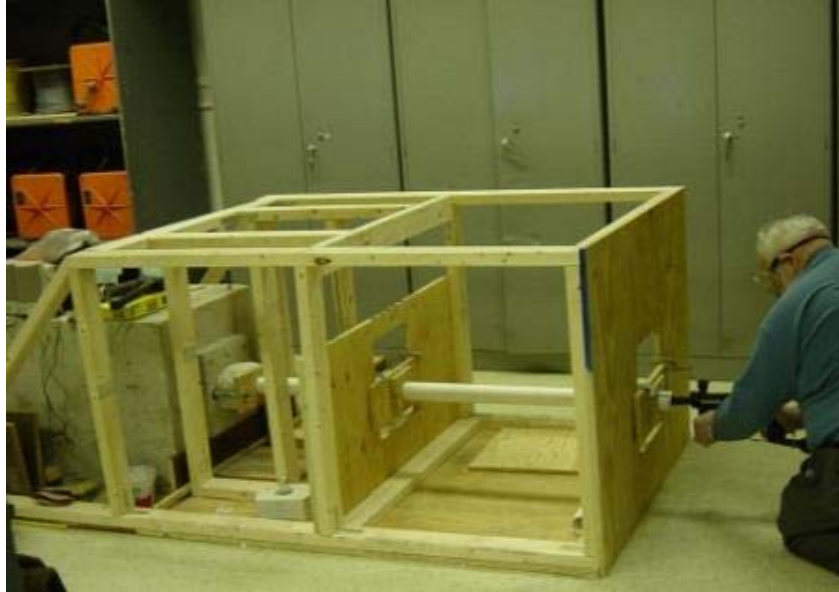
Figure 2.19 Laboratory test of paint gun.

indicated considerable energy in the range 100 – 5000 Hz. Pronounced peaks were noted in the range 400 – 600 Hz and strong peaks were noted at 1.4 kHz and 3 kHz. The paint gun was also tested underground at General Chemical (Figure 2.20).

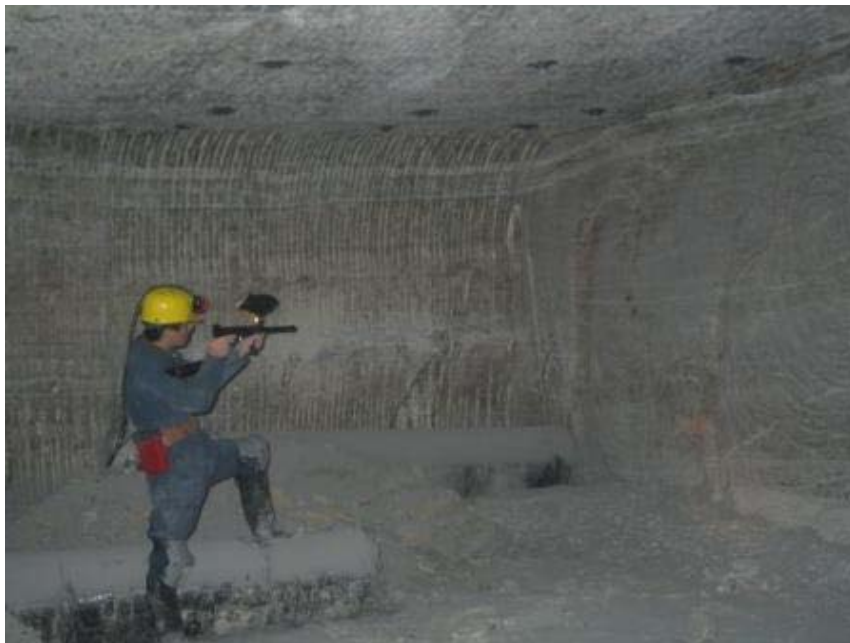
Figure 2.20 Paint gun test at General Chemical.

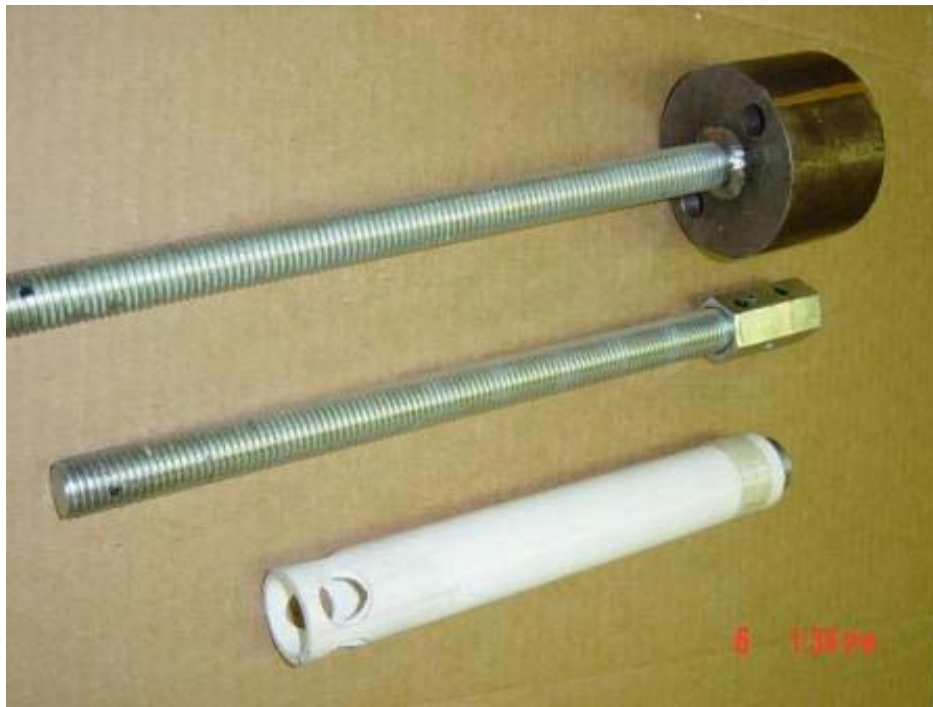
Figure 2.21 Simple mechanical impact system (SMIS).

The SMIS consists of an impact head, a steel rod with extensions, and an anchoring system (Figure 2.21). Figure 2.22 shows the detail of the anchoring system. Note the wooden pin laying by the steel anchor and the small holes on the steel anchor and the white pipe. Before installation, the wooden pin is used to hold the steel anchor to the white pipe and the steel rod is then connected to the anchor. The other end of the white pipe is used to hold the resin. After the SMIS reaches to the bottom of the borehole, an impact by hammer at the impact head will break the wooden pin and force the anchor sliding down along the white pipe, squeezing the resin out of the pipe. The anchor is then firmly grouted by the squeezed resin at the bottom of the borehole. Since the connection between the steel rod and the anchor is a screw connection, the steel rod and impact head can be retrieved or reinstalled.

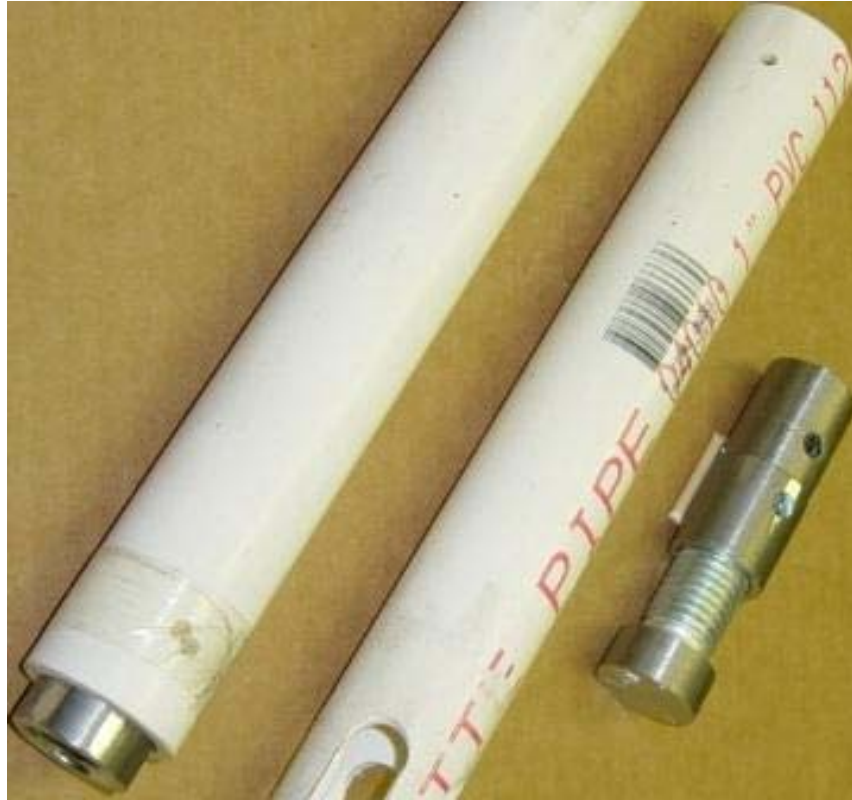
Figure 2.22 SMIS anchor structure.

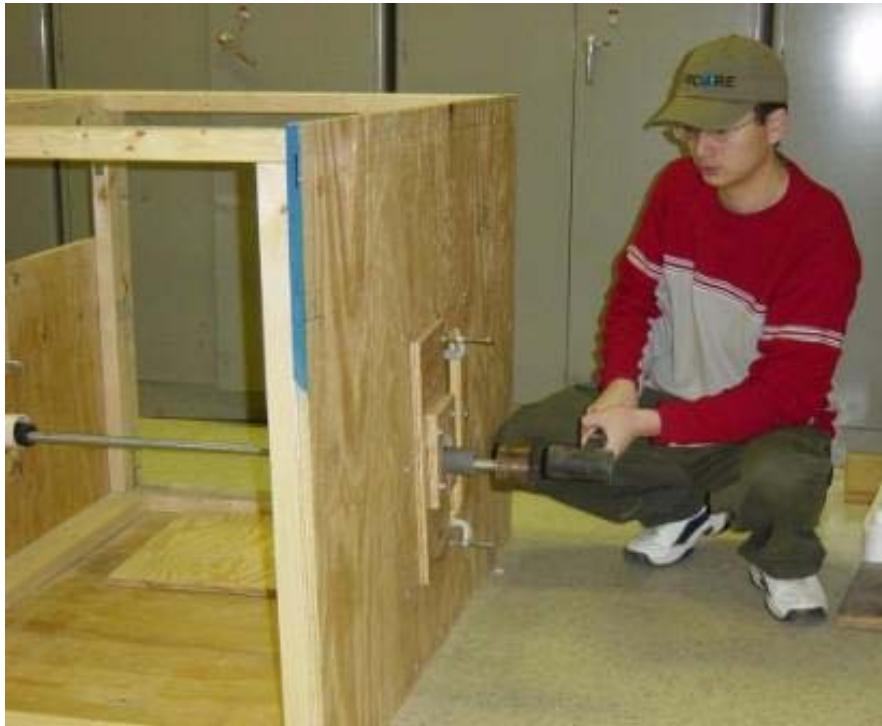
Figure 2.23 Laboratory testing of non-explosive sources with the help of SMIS.

SMIS was tested both in the laboratory (Figure 2.23) and field. Figure 2.24 shows the field installation of SMIS at Harmony mine. The signals generated by a hammer impact at this SMIS and received by the sensors located on the other side of the pillar, which is approximately 50 feet away, are shown in Figure 2.25. Both P- and S-wave arrivals can be clearly seen. Their frequencies are approximately 3,000 Hz and 1,100 Hz, respectively.

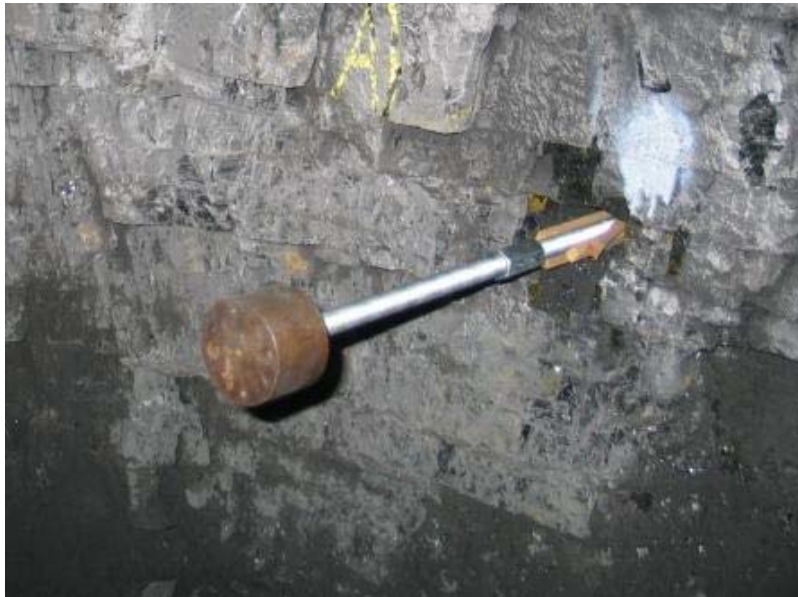
Figure 2.24 A Simple Mechanical Impact System (SMIS) installed in a coal pillar.

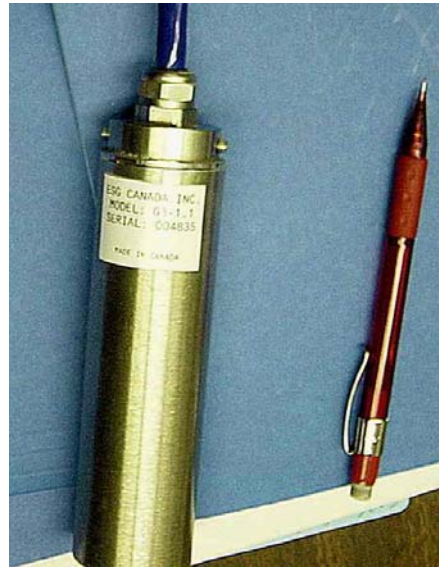
Figure 2.26 A three-dimensional accelerometer.

In order to determine whether an incoming signal is a reflected signal, the type (P- or S-wave) and direction of this signal must be known. A reliable means of acquiring this information is to compare how signals are polarized and three-dimensional sensors are ideal for this purpose. A three-dimensional accelerometer is shown in Figure 2.26. Figure 2.27 is an illustration of the 3D sensor configuration and the signals detected by a 3D sensor.

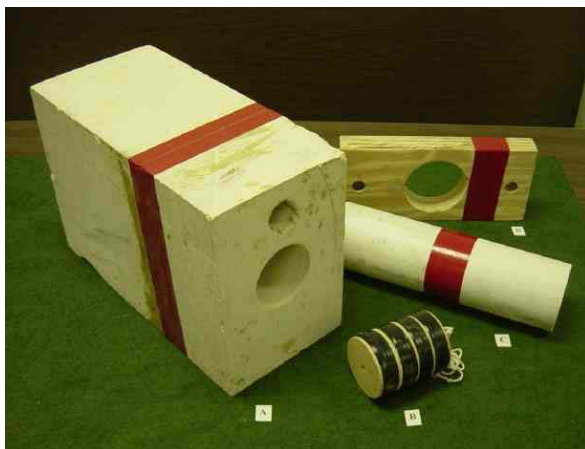
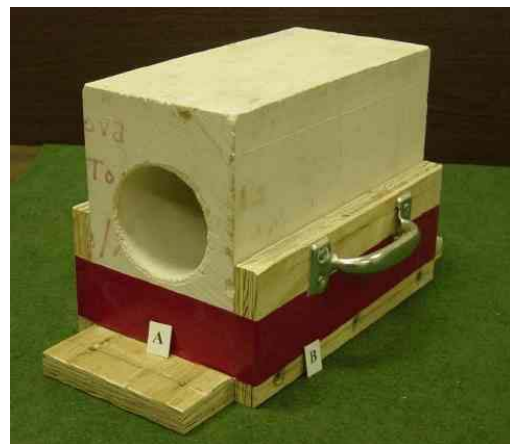
Figure 2.29 Limestone blocks with boreholes for 3D sensor installation.

a. 7" x 10" x 18" in limestone block.

b. 5" x 7" x 10" in limestone block.

In preparation for testing of future 3-D installation tools, a number of testing facilities were developed, including 1) a large concrete block and a borehole support frame (Figure 2.28), 2) two large specially prepared limestone blocks with drill holes for 3D and 1D sensor installation (Figure 2.29), 3) a hydraulic platform for supporting limestone blocks (Figure 2.30a), and 4) a specially designed borehole system (Figure 2.30b).

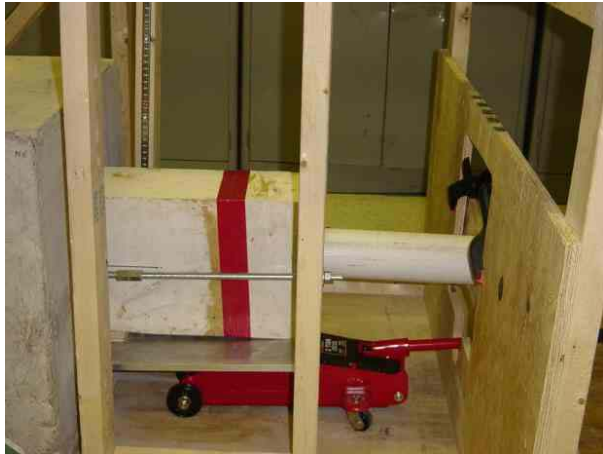
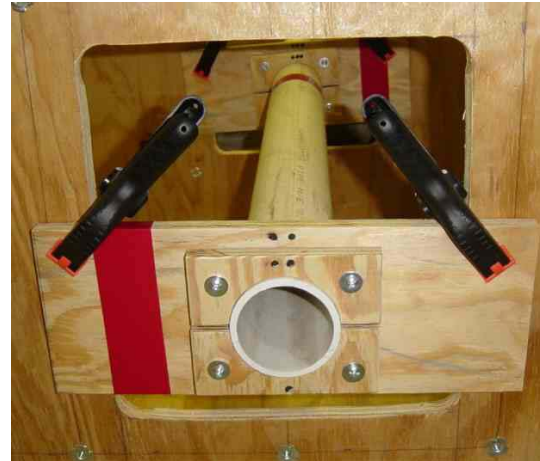
Figure 2.30 3D sensor testing support systems.

a. Hydraulic supporting platform.

b. Specially designed borehole system.

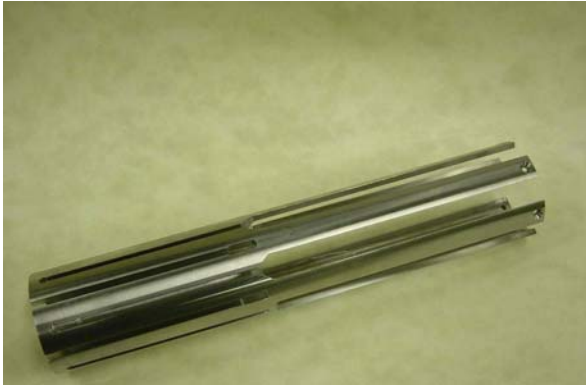
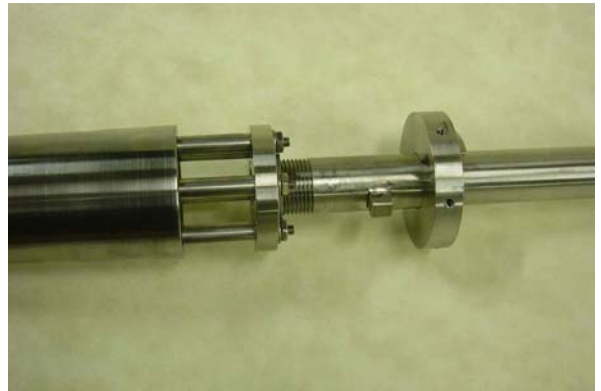
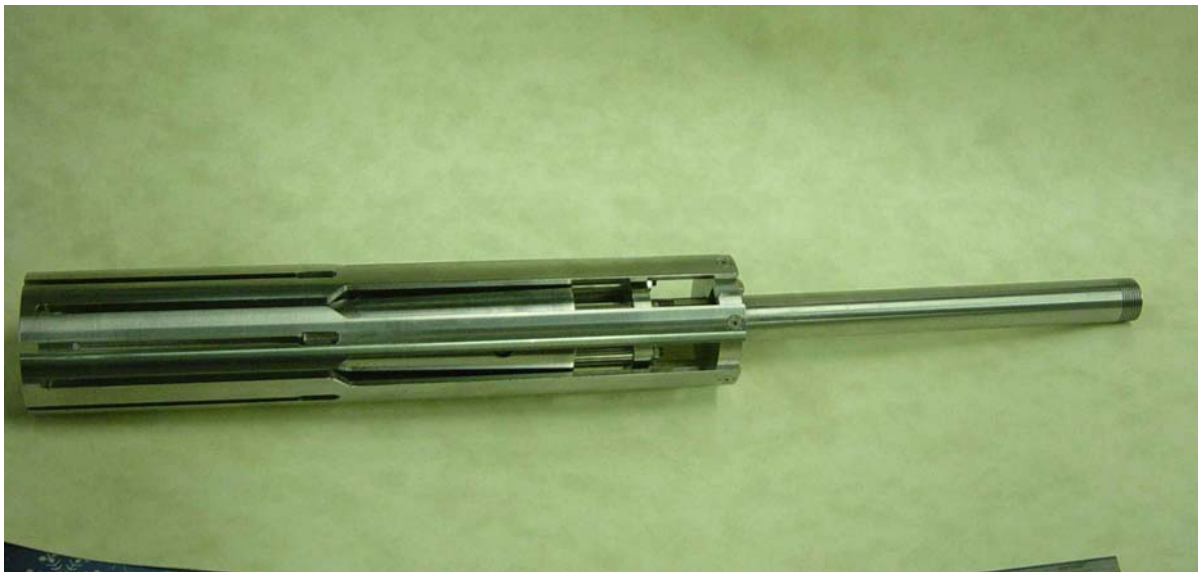
Figure 2.31 Retrievable 3D sensor installation device.

a. Outer sleeve.

b. Inner sleeve.

c. Assembled unit.

The 3D sensor installation device developed at Penn State is based on the “expandable mandrel” concept used in holding odd sized hollow cylindrical work pieces in a lathe (Figure 2.31). In this case, the inside of the mandrel and an associated center rod are each machined with a 1 degree taper. When the horizontal center rod is thrust into the mandrel it expands radially and uniformly in all directions in the vertical plane insuring that the 3-D sensor is in intimate contact with the borehole wall.

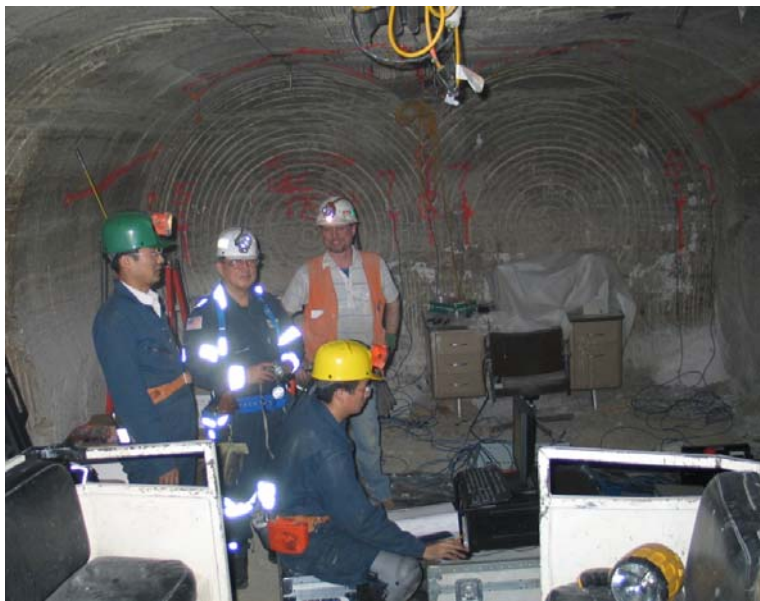
Figure 6.6 Field station for transmission survey, where the sensor holes were drilled at the face of the entry and the collar locations were marked by the vertical red lines.

Because of accessibility limitations, sensors had to be installed in the short entry shown in Figure 6.6, which was approximately 16.5 ft wide. This short entry also served as the field station for the transmission survey.

The arrangement of the sensor holes is shown in Figure 6.7. Seven sensor holes were drilled at the back of the entry, where the collar locations can be seen from Figure 6.6 as the vertical red lines marked at the back. Sensor holes were numbered from S1 to S7. Among them, S2, S4 and S6 were straight and the others were angled 45° or 135° horizontally from the rib. The length of sensor holes was 5 ft for straight holes and 7 ft for angled holes. The diameter for all sensor holes was 1.75". The sensor hole information is summarized in Table 6.1.

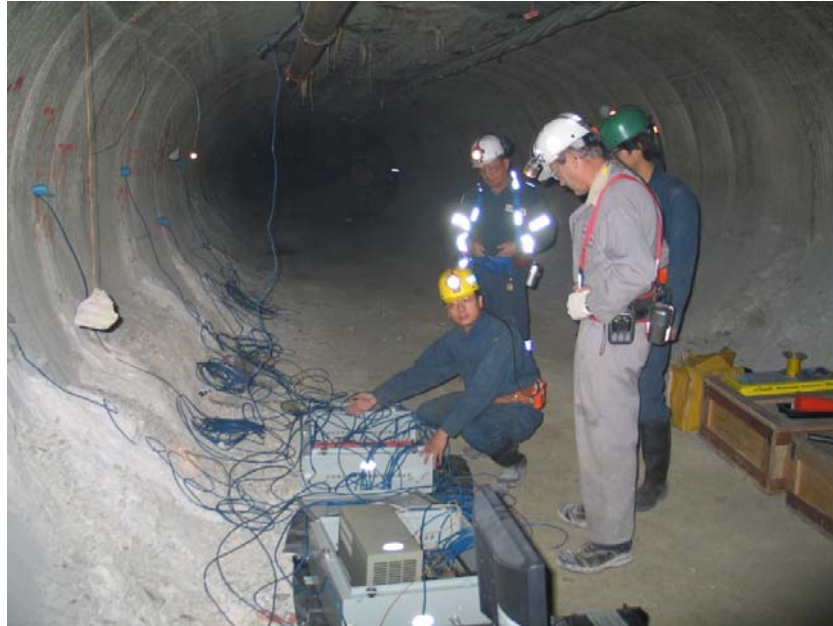
Figure 8.2 Underground working station for field demonstration at Site A, FMC.

The field demonstration was held at Site A, 349 West Development, from 10:00 am to 2:00 pm. Figure 8.2 is a scene of the testing site, where the retrievable sensors were installed and the data acquisition system was set.

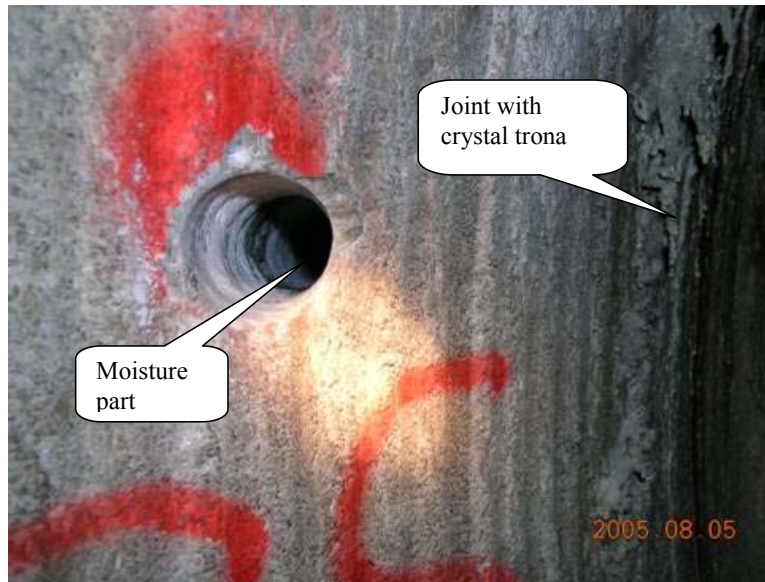
Figure.8.3 A trace of moisture showed in Sensor hole S5.

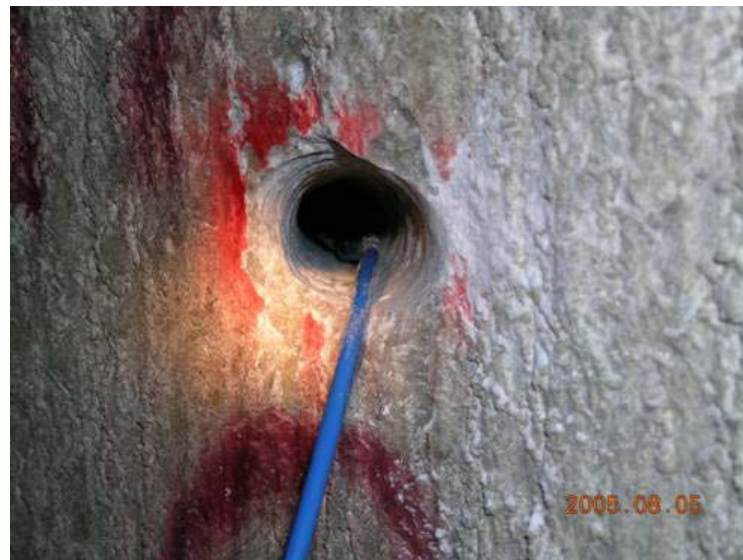
Figure 8.4 Retrievable sensor was installed in the sensor hole used five months earlier.

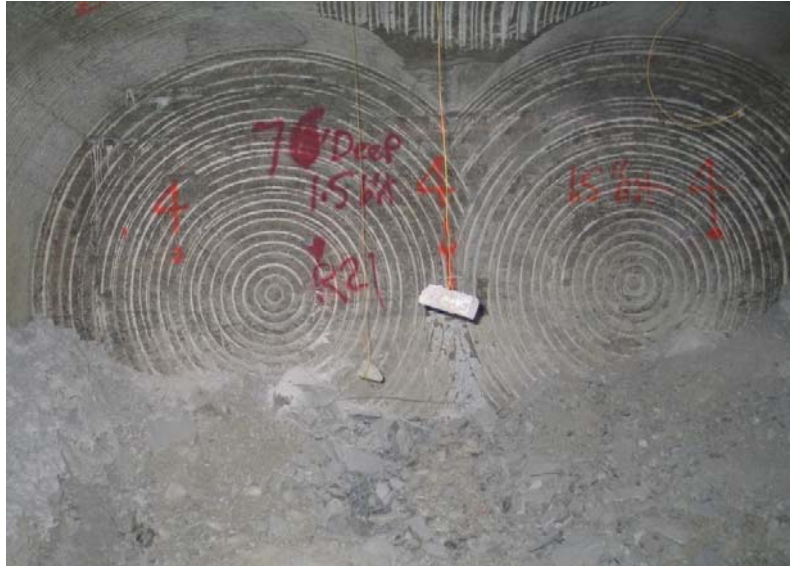
Alignment strings were used for guiding the drilling direction for both sensor and blasting holes.

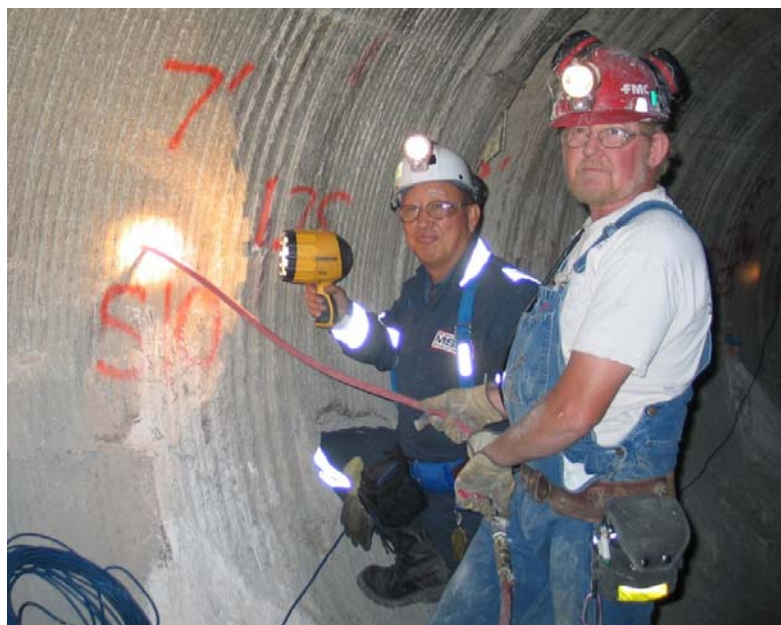
Compressed air was used for creating “dust free” sensor holes.

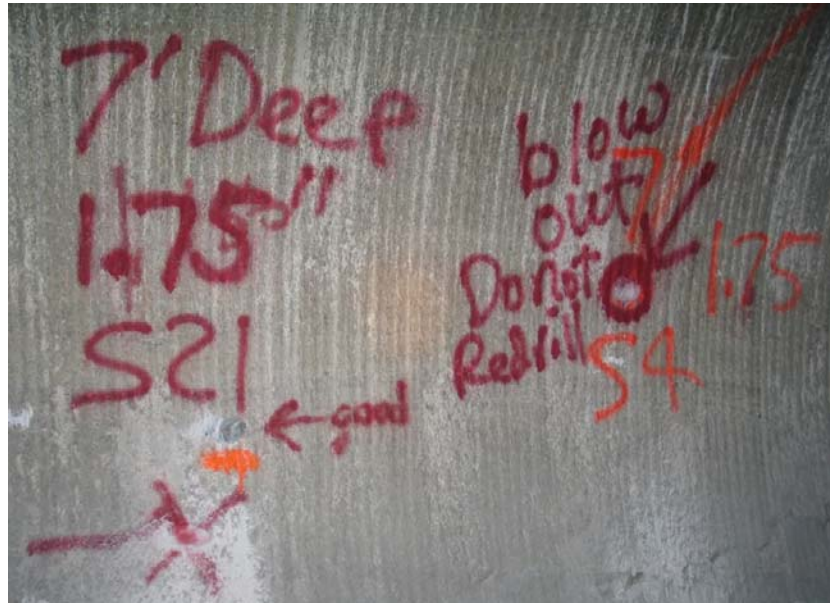
Existing and newly drilled sensor holes (S21 was a newly drilled sensor hole for the demonstration. The parameters of the hole were marked clearly on the wall: 7' deep with a diameter of 1.75". S4 was drilled for the previous test and was reused for the demonstration. As marked by "blow out", it was further cleaned before the demonstration).

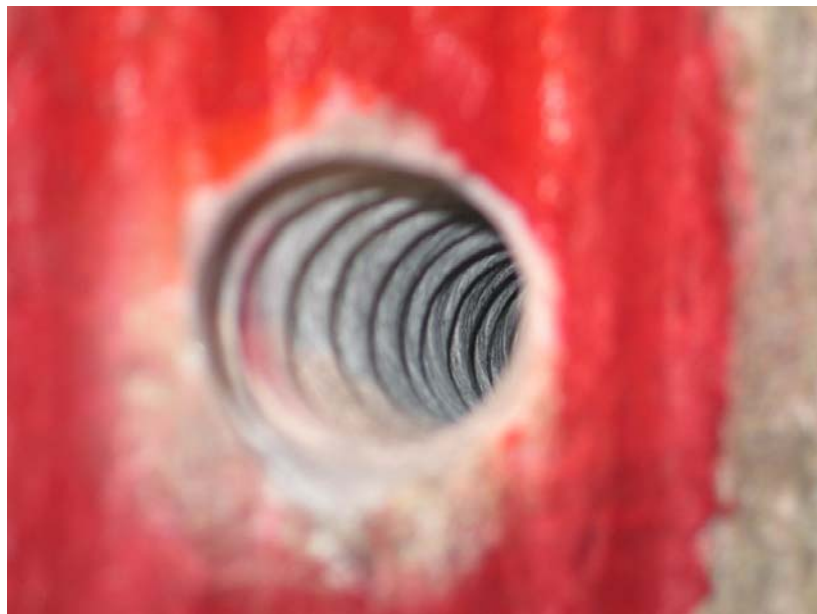
A thoroughly cleaned and dust-free sensor hole.

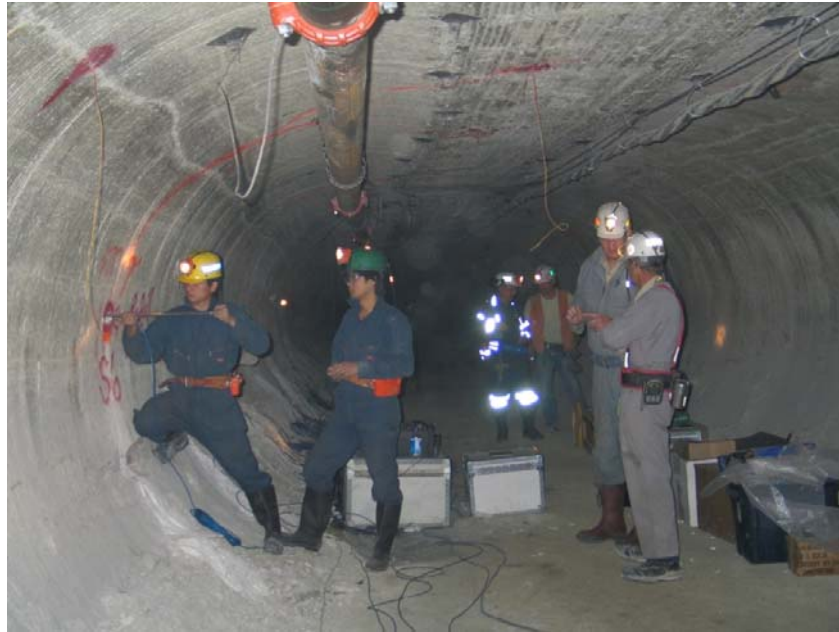
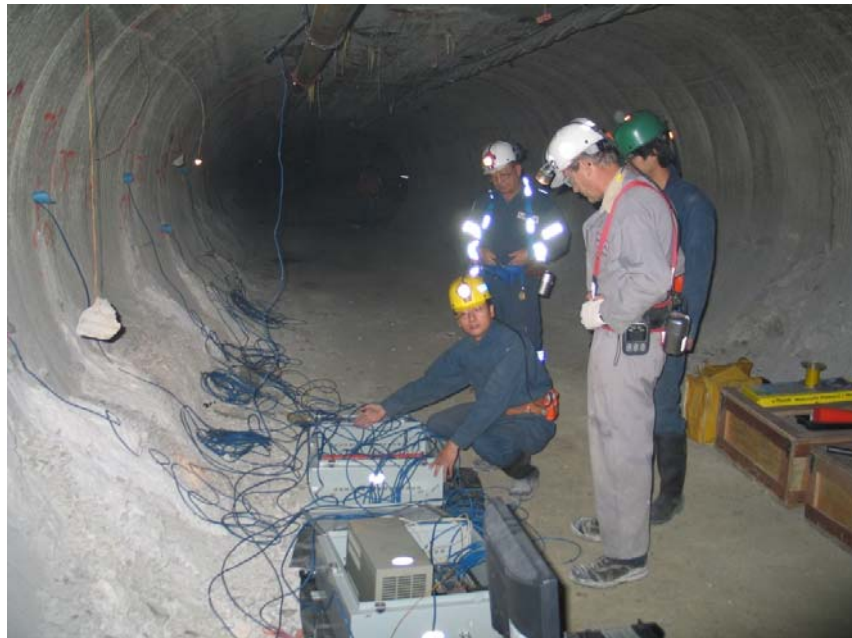
Data acquisition system and sensor locations (The locations of the sensor holes are shown by the outlets of the blue cables as well as the blue insulation material plugged at the hole collar, the sound barrier).

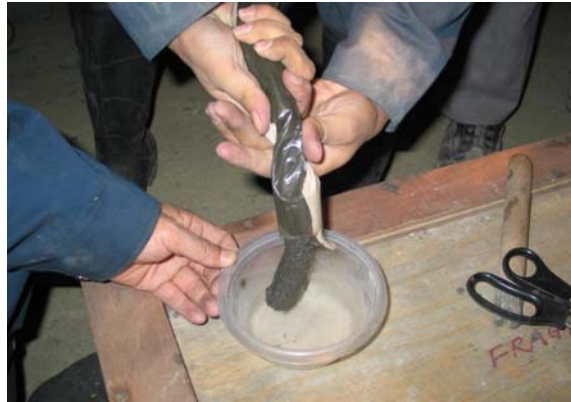
Squeezing the resin out from a two-compartment tube.

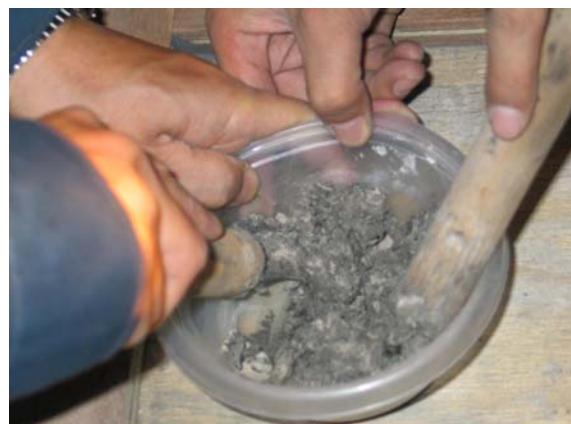
Mixing resin with one-slot dowels.

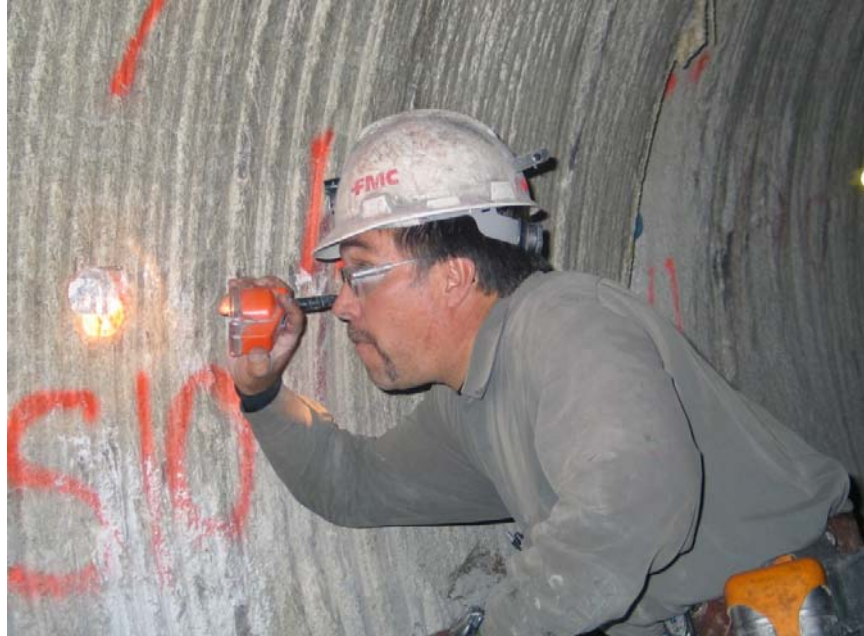
Sensor holes were carefully cleaned and inspected prior to sensor installation.

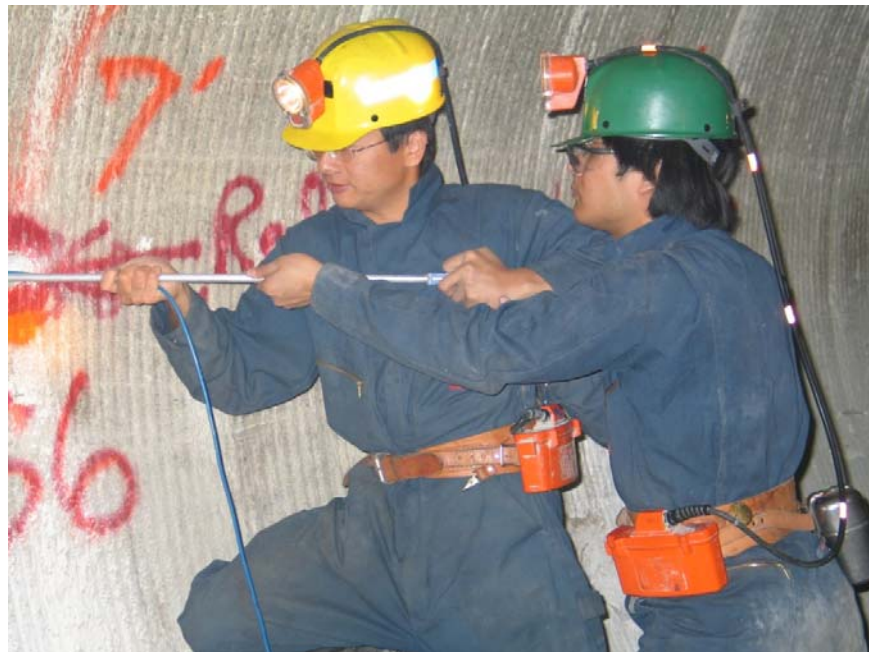
Sensor installation.

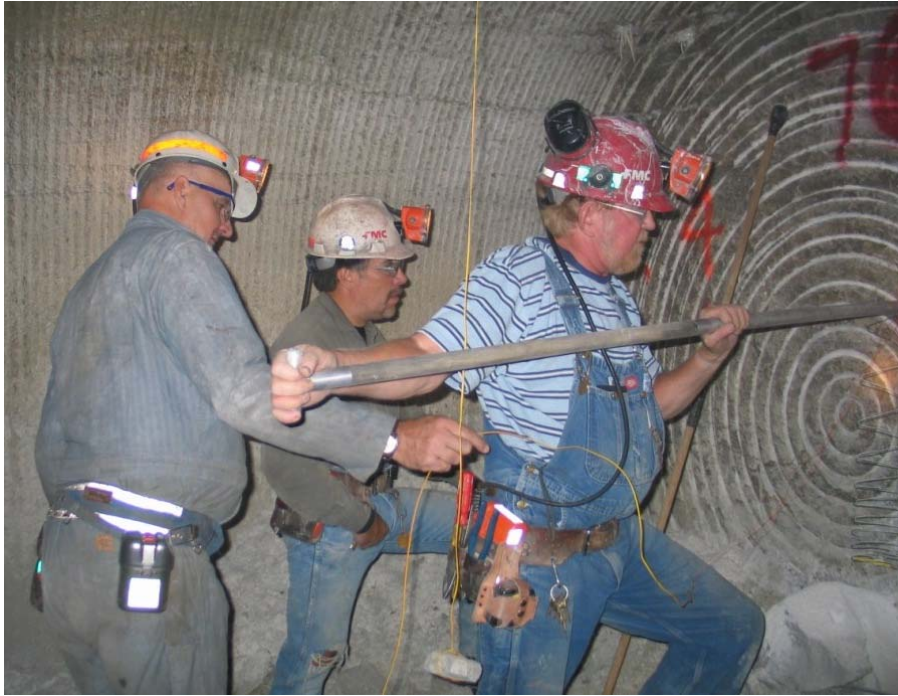
Stemming a blasting hole.

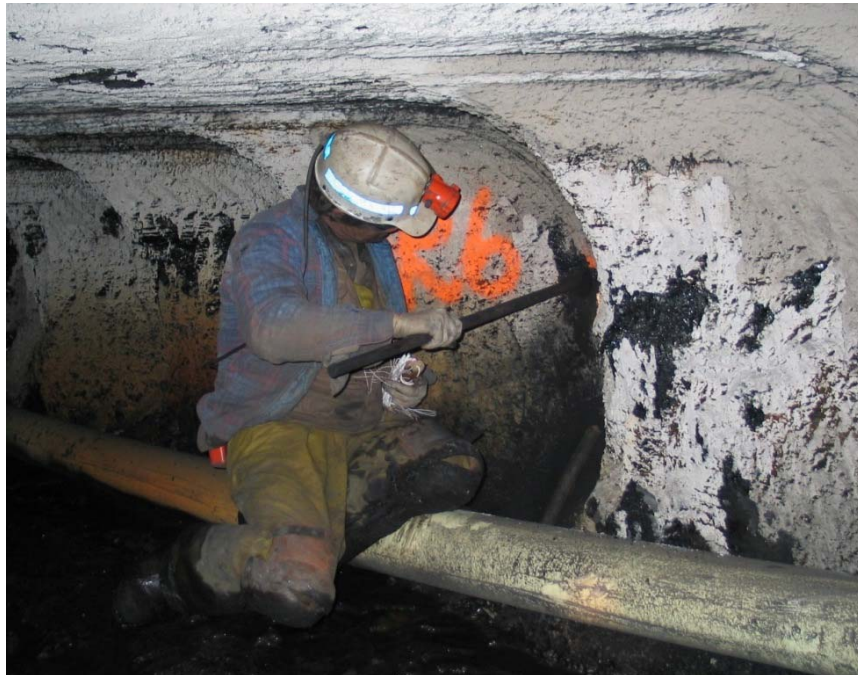
Figure 9.10 Clean blasting hole R6 for reflection test.

Among 23 drilled blasting holes, 22 were used. The one that was not used is R17. All blasting holes were loaded with 375 grams of the explosive. The blasting holes were cleaned before loading and stemmed with 18” long clay dummies after loading. Several blasting related operations are shown in Figures 9.10 – 12.

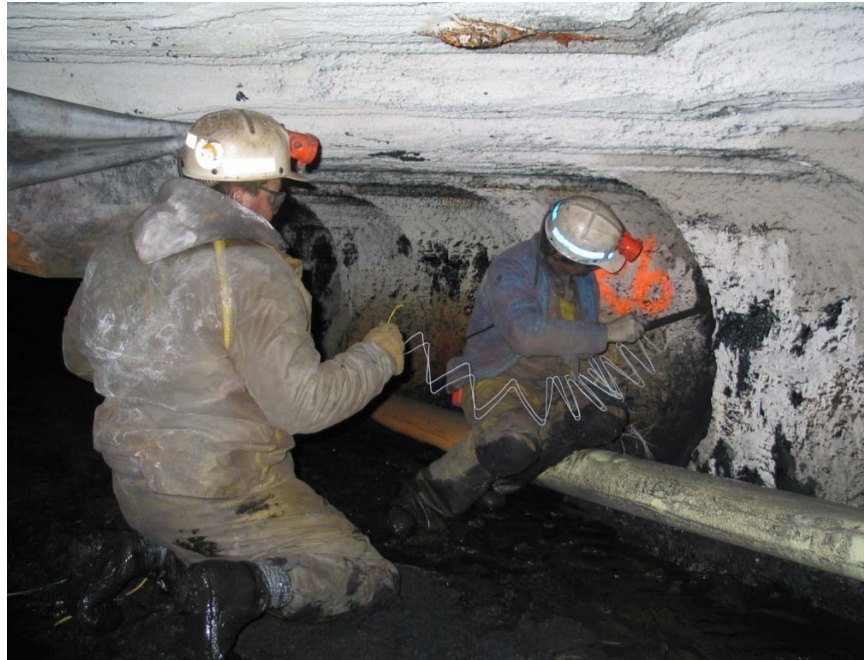
Figure 9.11. Setup the explosive for hole R6.

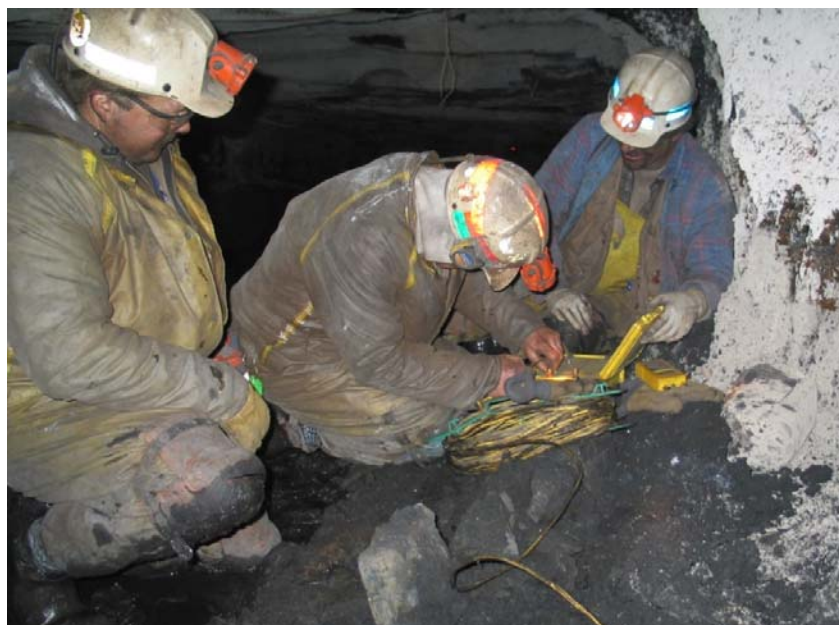
Figure 9.12 Preparing the detonation.

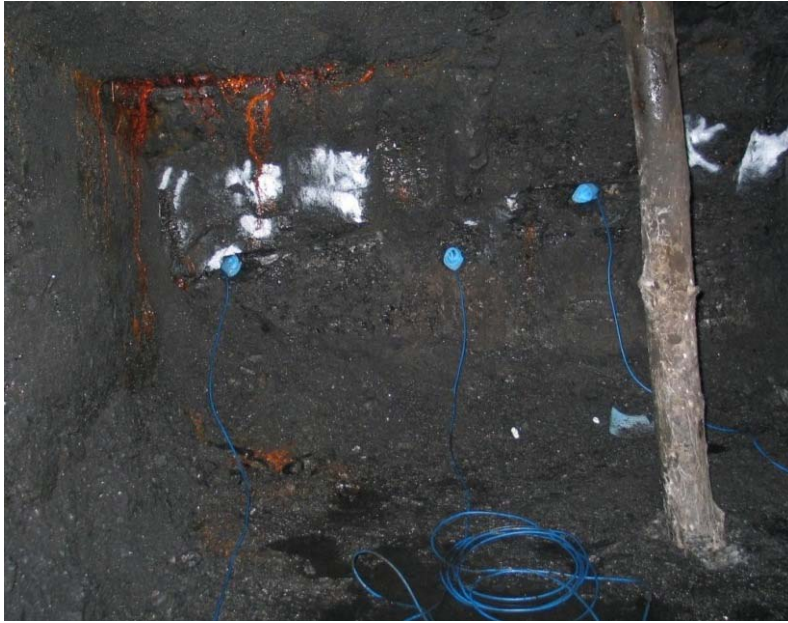
Figure 9.17 Sensor holes were sealed with the blue foam to prevent the interference by shock waves (picture was take at testing site II, Harmony Mine).

Because of their severe effect, measures have to be taken to reduce the magnitude and impact of shock waves. There are three possible measures. The first one is to seal sensor holes with insulation materials, which should be a standard operational procedure. The second one is to reduce the amount of explosives to be used if possible. The third one is to place blasting holes in different entries if it is feasible. The third measure is a very effective means based on our experience.
